## South Rand Hospital - Rain Damage and Water Leak Incident Report

**Date of Report:** 7 November 2025

**Subject:** Documentation of water ingress and leak incidents following rainfall 06/11/2025.

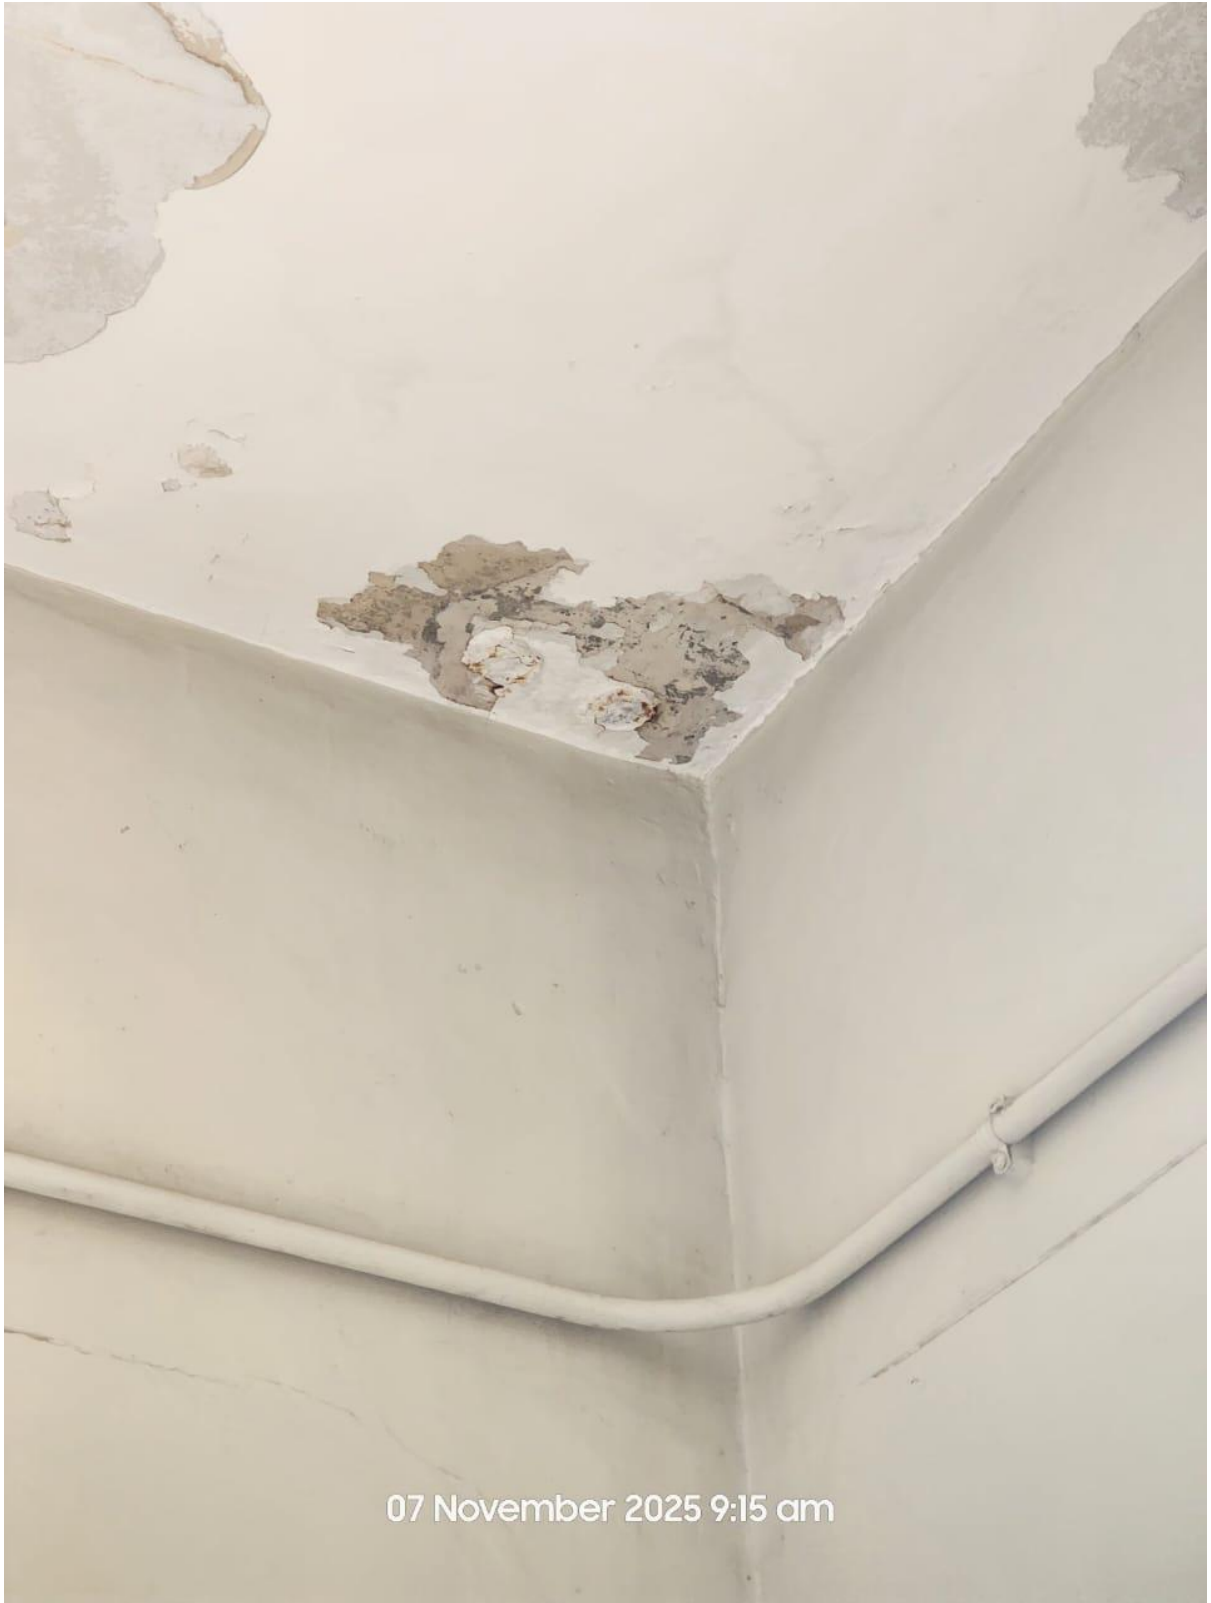
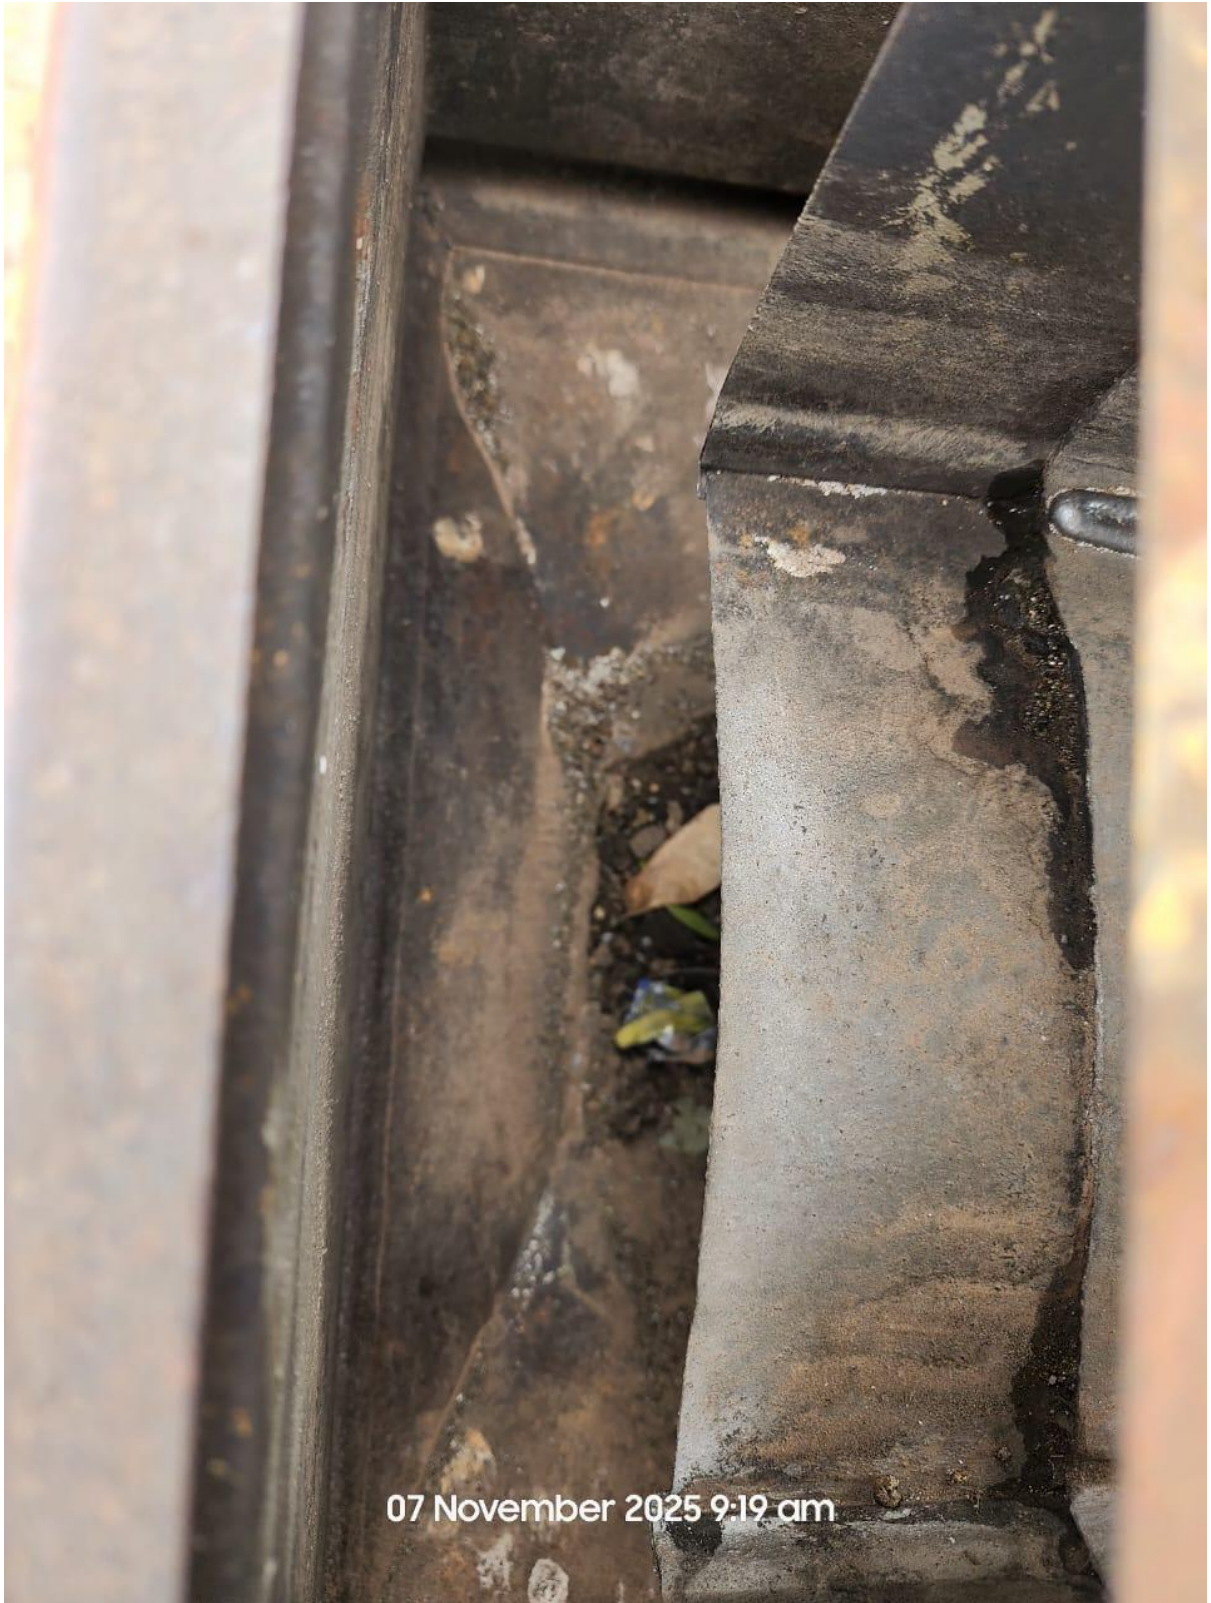
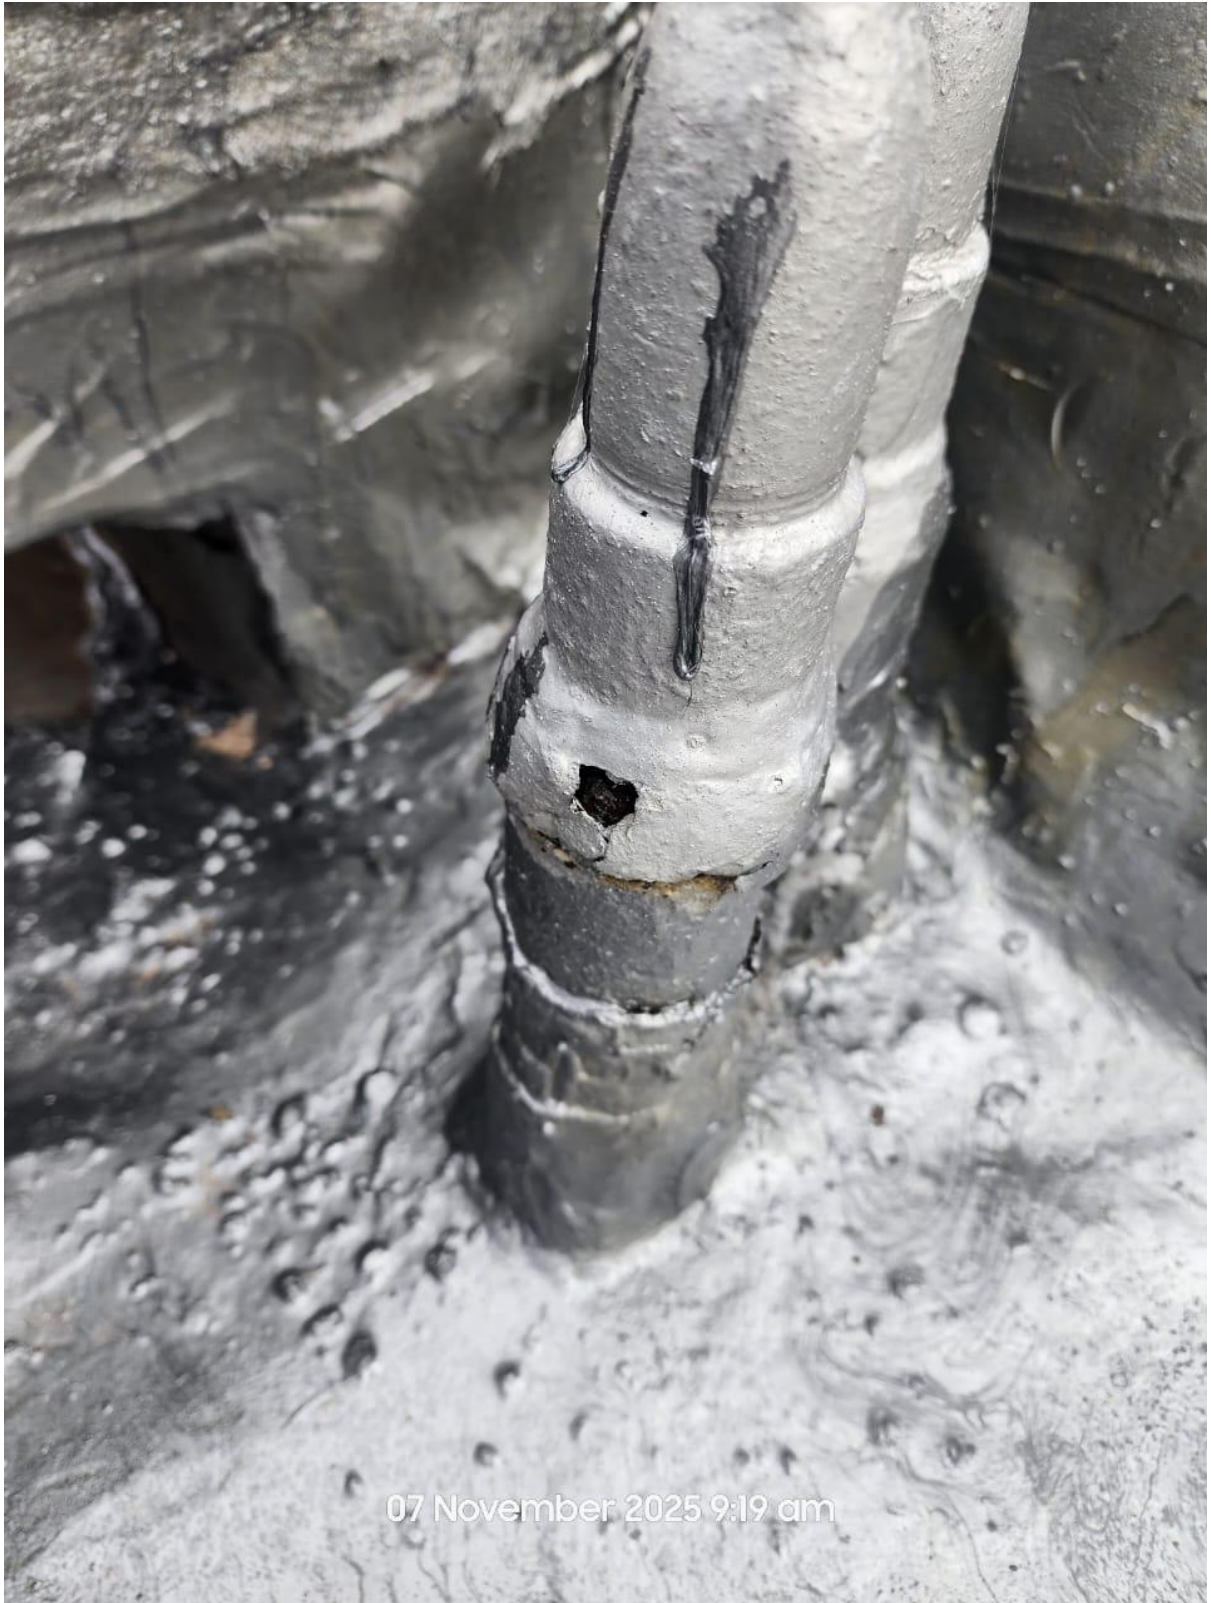
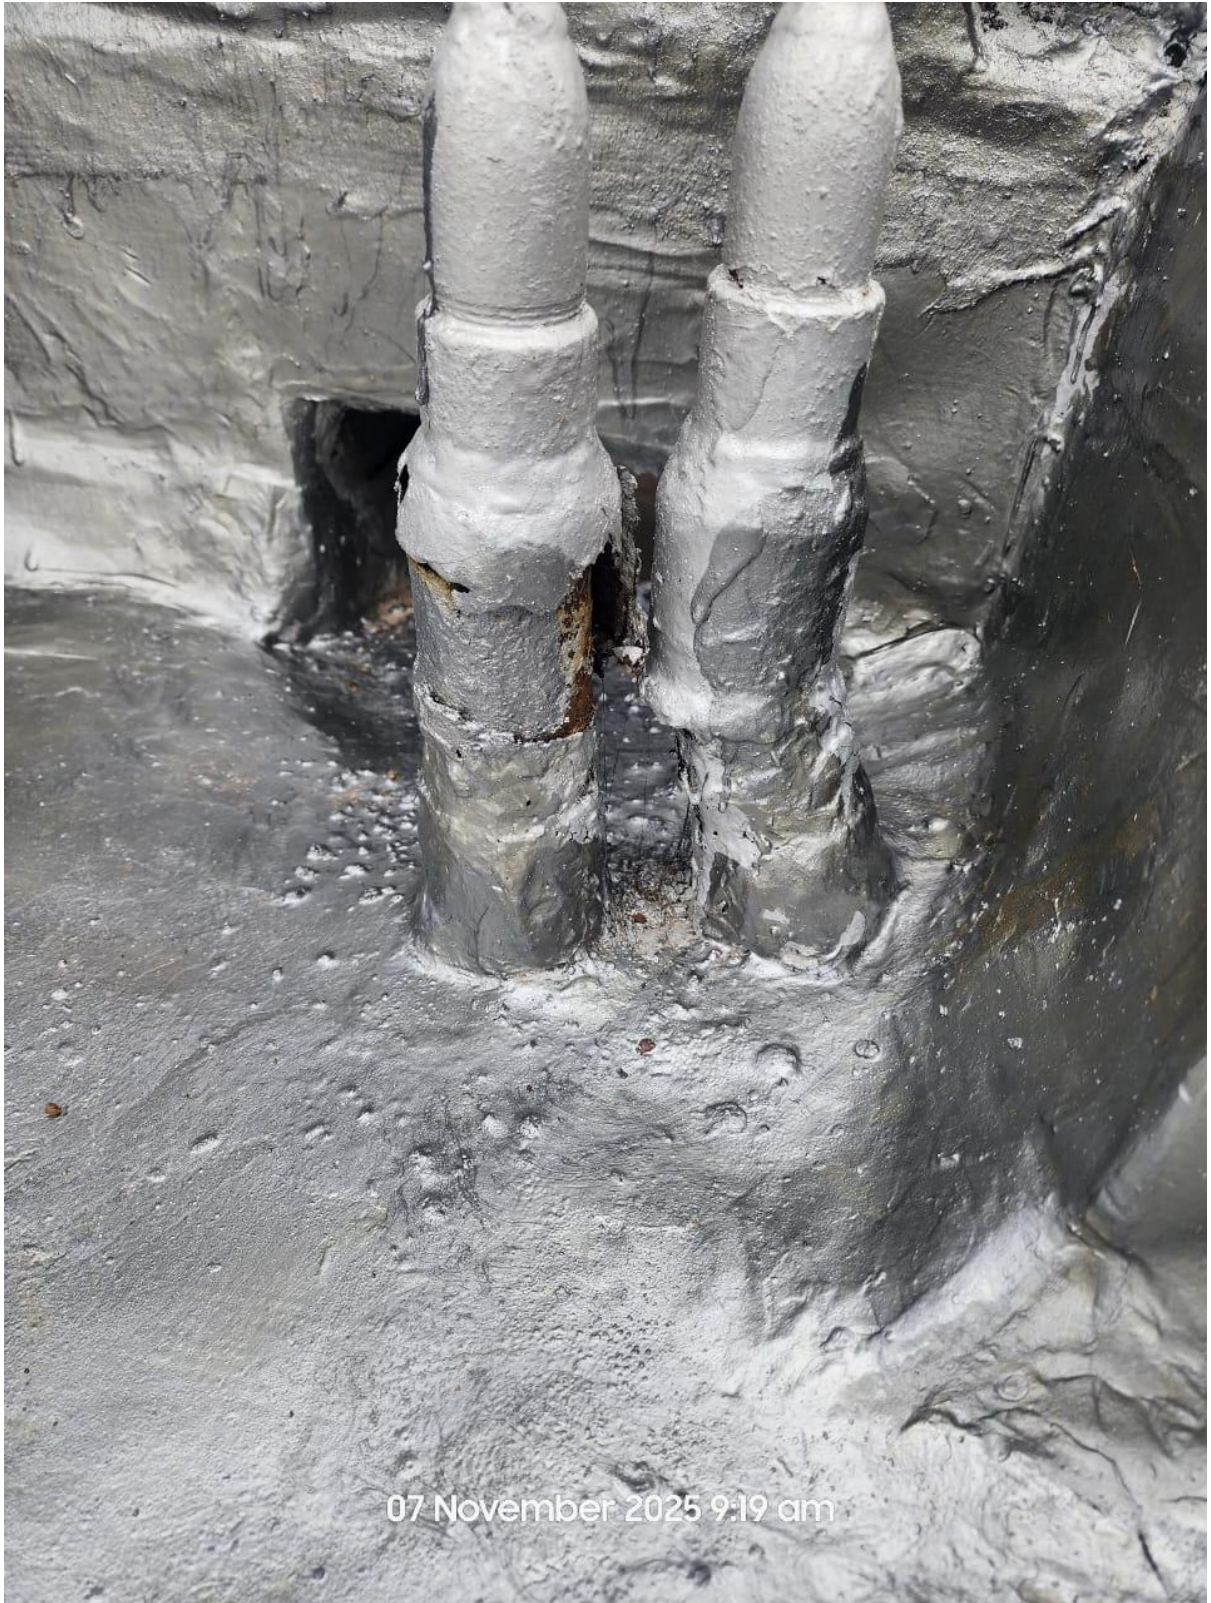
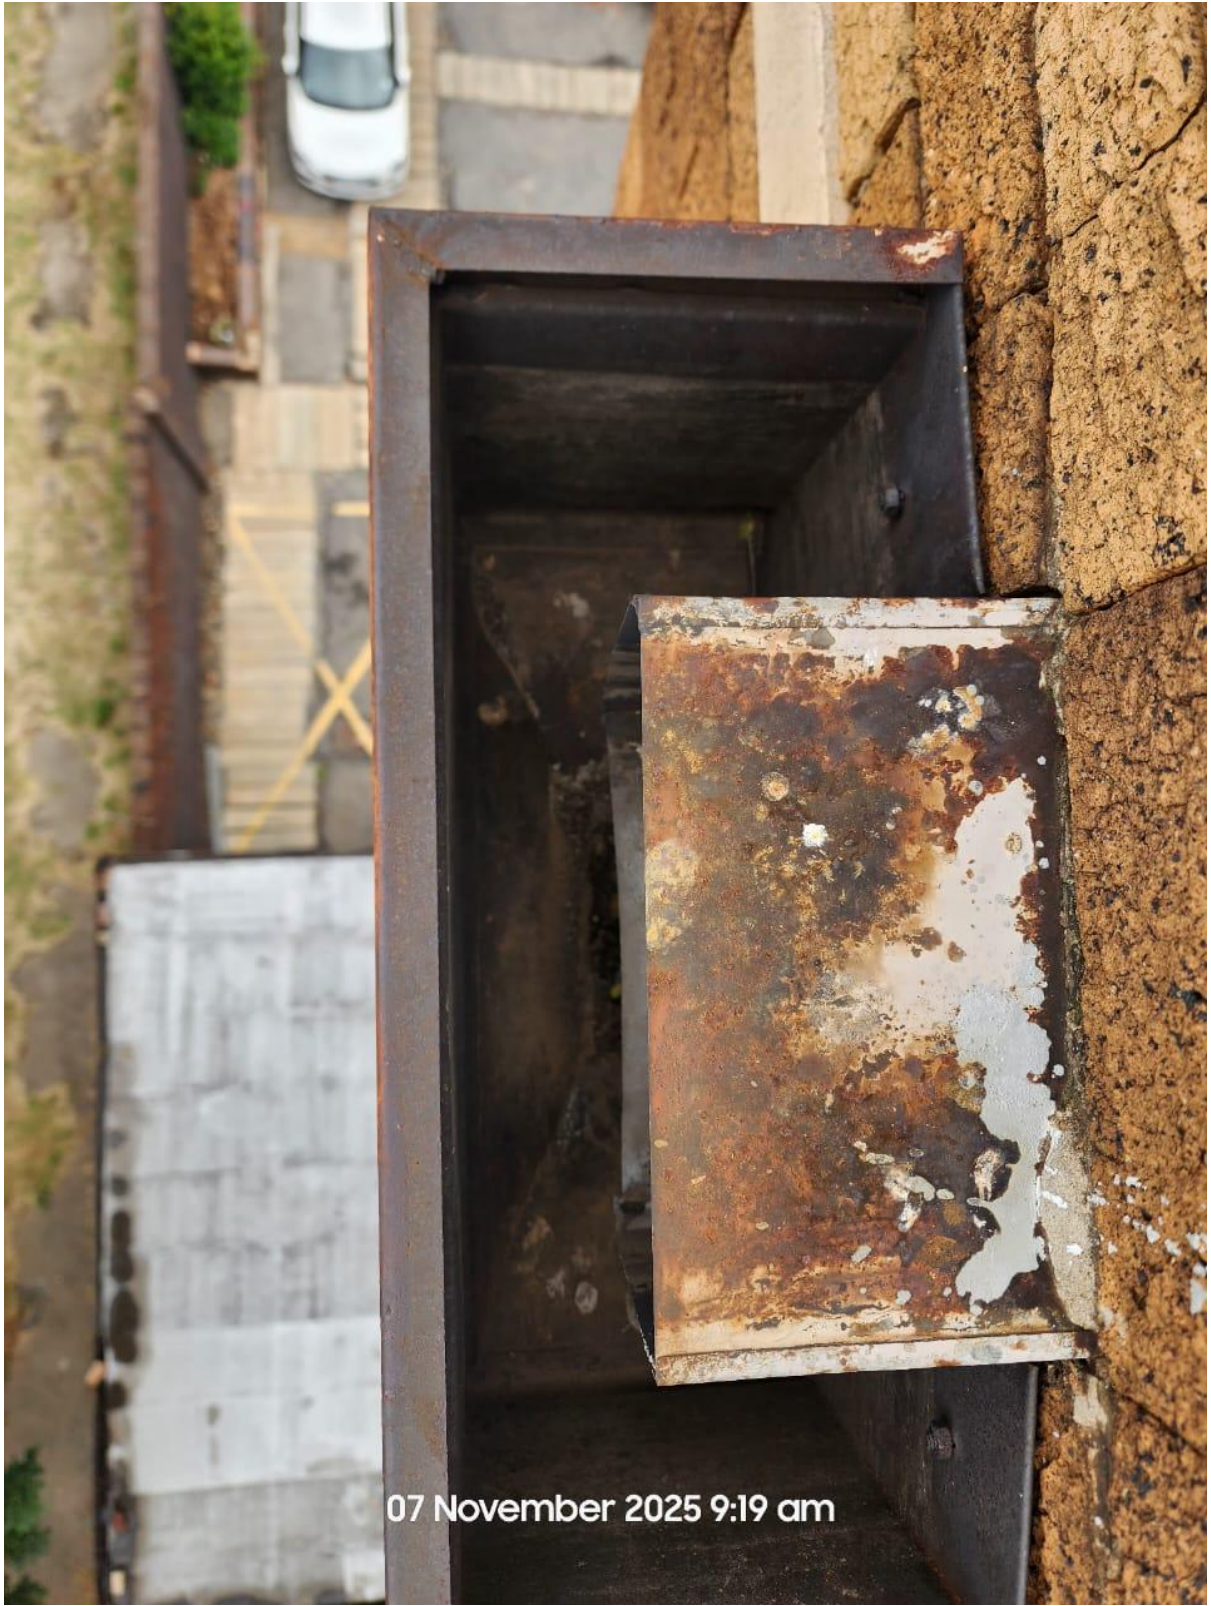
### Incident 1: Ward 8 Staff Tea Room

This incident appears to be directly related to a maintenance failure on the roof level (**but is not, refer to cause of leak in table below**) resulting in significant water pooling and structural seepage.

Detail	Description
Area Affected	Ward 8 Staff Tea Room (Ceiling)
Location	Ceiling leak, directly below the fourth-floor roof level.
Cause of Leak	A <b>blocked downpipe</b> from the fourth floor caused rainwater to pool (dam up) extensively on the roof of Ward 8. The pooled water reached the height of two existing, <b>old rusted pipes</b> on the roof, from which it seeped into the tea room ceiling below.
Proposed Solution	1. <b>Immediate:</b> Seal the rusted components of the two exposed old pipes on the roof. 2. <b>Critical Action:</b> The blocked downpipe must be cleaned out immediately to ensure effective rainwater drainage and prevent future water damming on the roof.
Visual Reference	(See attached picture 1: Ward 8 Leak)

The immediate priority must be the clearing of the **blocked downpipe (Incident 1)** to secure the roof and prevent major structural damage from pooling water.

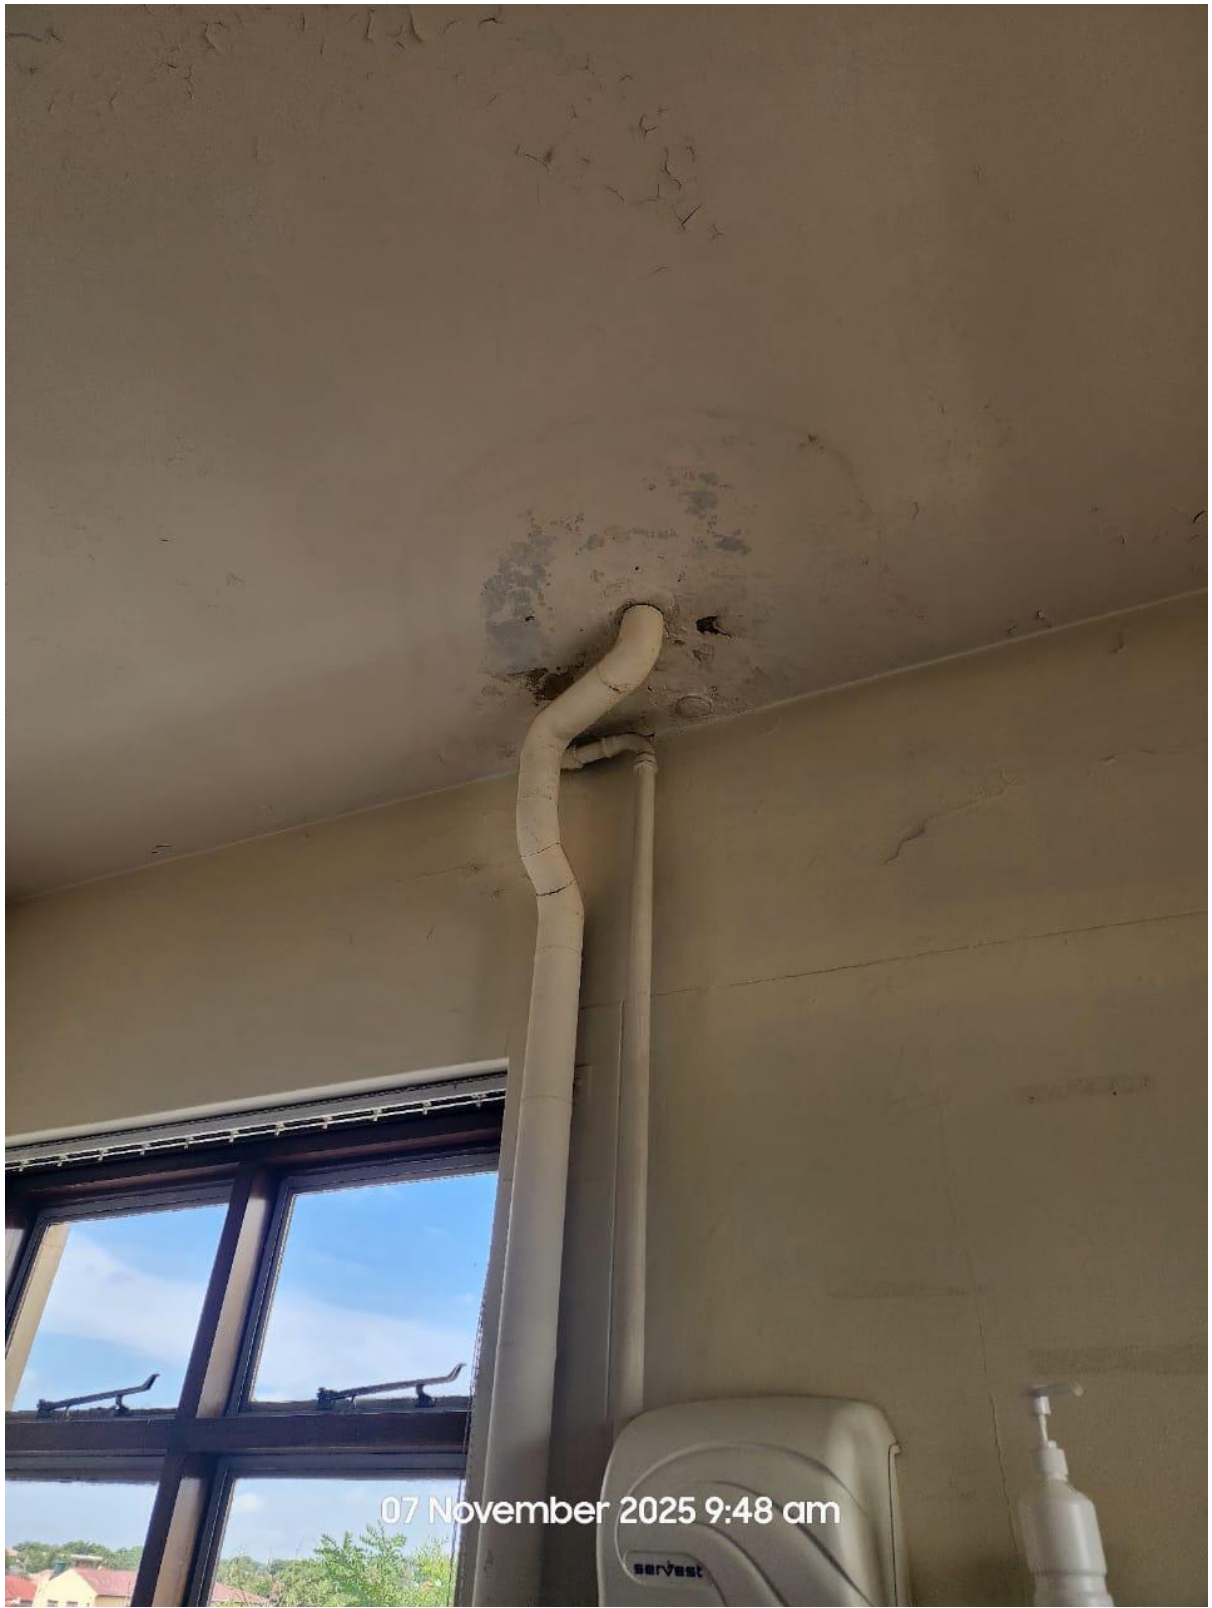
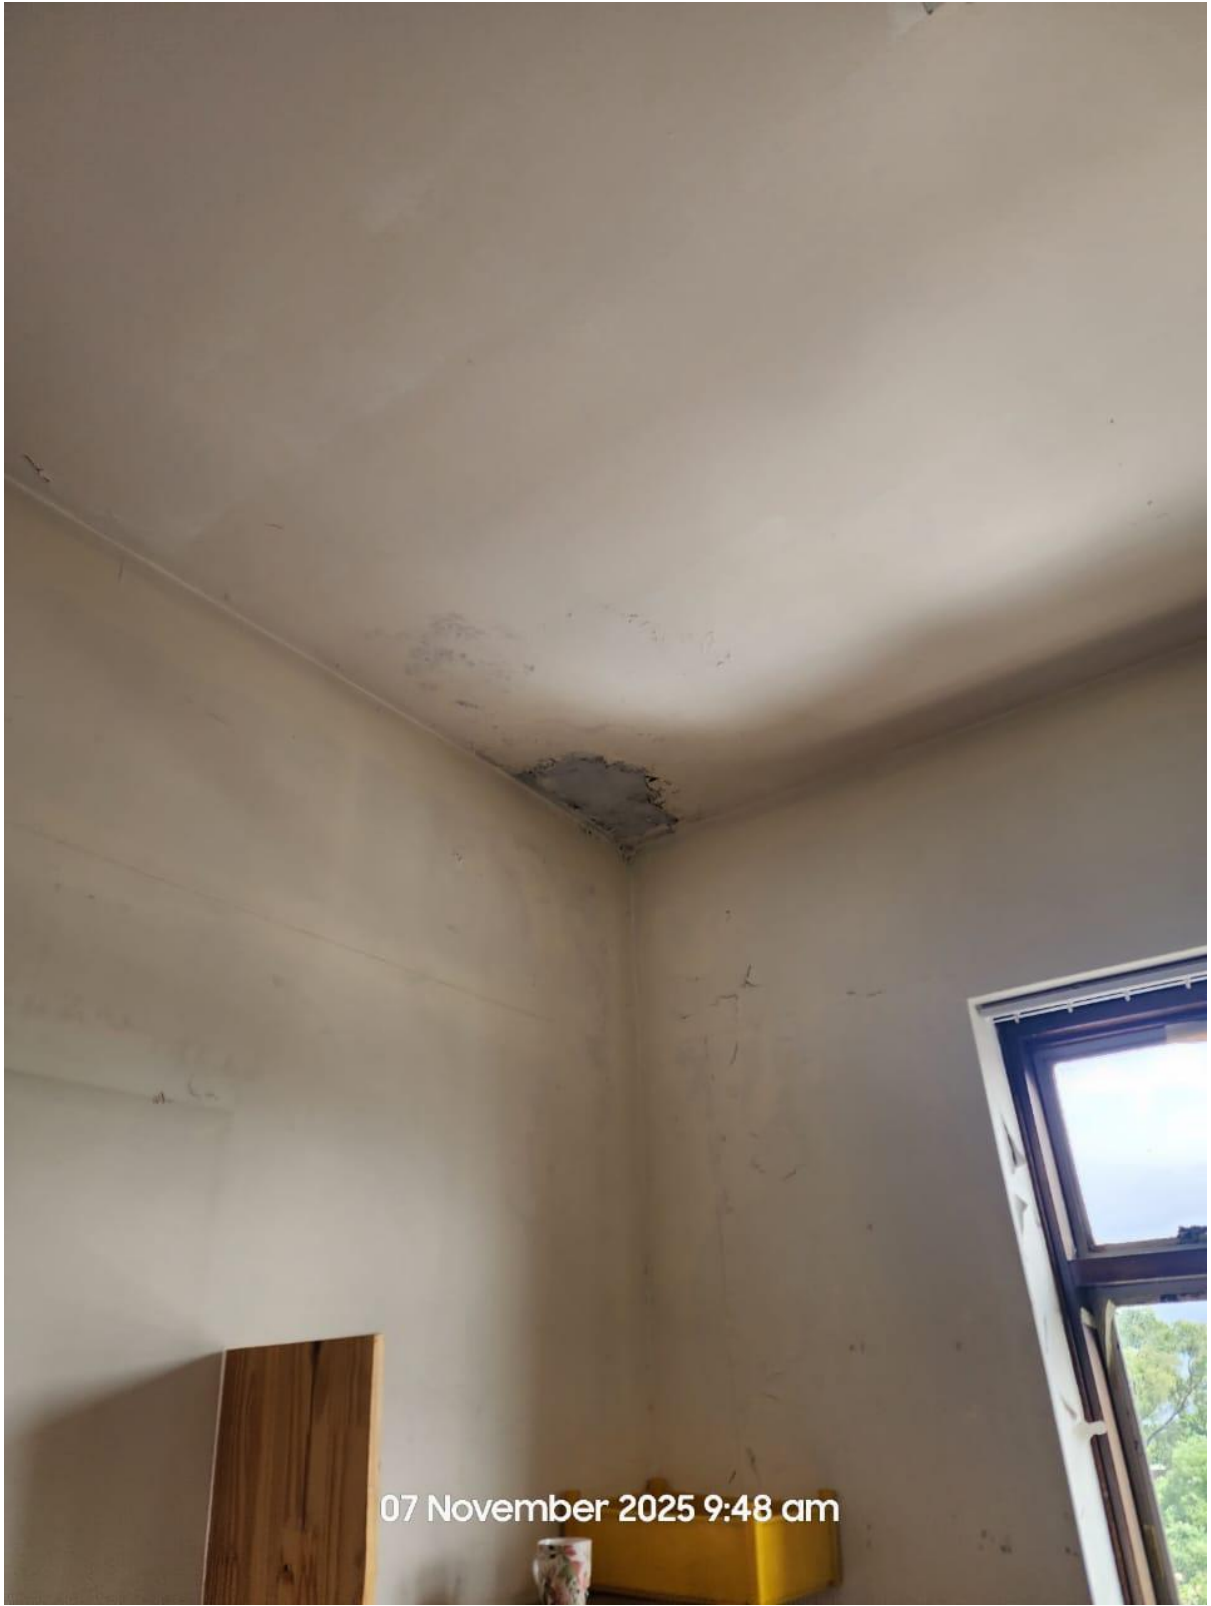
## Incident 2: Speech Therapy & Audiology

This leak is attributed to a failure in external building elements (windows) and plumbing from the floor above, rather than a general roof issue.

<b>Detail</b>	<b>Description</b>
<b>Area Affected</b>	Speech Therapy & Audiology Department
<b>Location</b>	2nd Floor, with water originating from the 3rd Floor (Ward 5).
<b>Cause of Leak</b>	<ol style="list-style-type: none"><li><b>Plumbing Leak:</b> Water is leaking from the 3rd floor (Ward 5) ceiling into the 2nd floor department. <b>(Confirmed not a roof leak).</b></li><li><b>Structural Issue:</b> Rainwater is also <b>seeping in from the windows</b>, indicating necessary repairs to window seals or frames.</li></ol>
<b>Proposed Solution</b>	<ol style="list-style-type: none"><li>Investigate and repair the source of the leak originating from the 3rd Floor (Ward 5).</li><li>Conduct immediate repairs and sealing on the windows to prevent further rain ingress.</li></ol>
<b>Visual Reference</b>	(See attached picture 2: Speech/Audiology Leak and Windows)

All identified window repair needs (Incidents 2 & 3) should be scheduled for repair simultaneously to address immediate rain seepage risks.

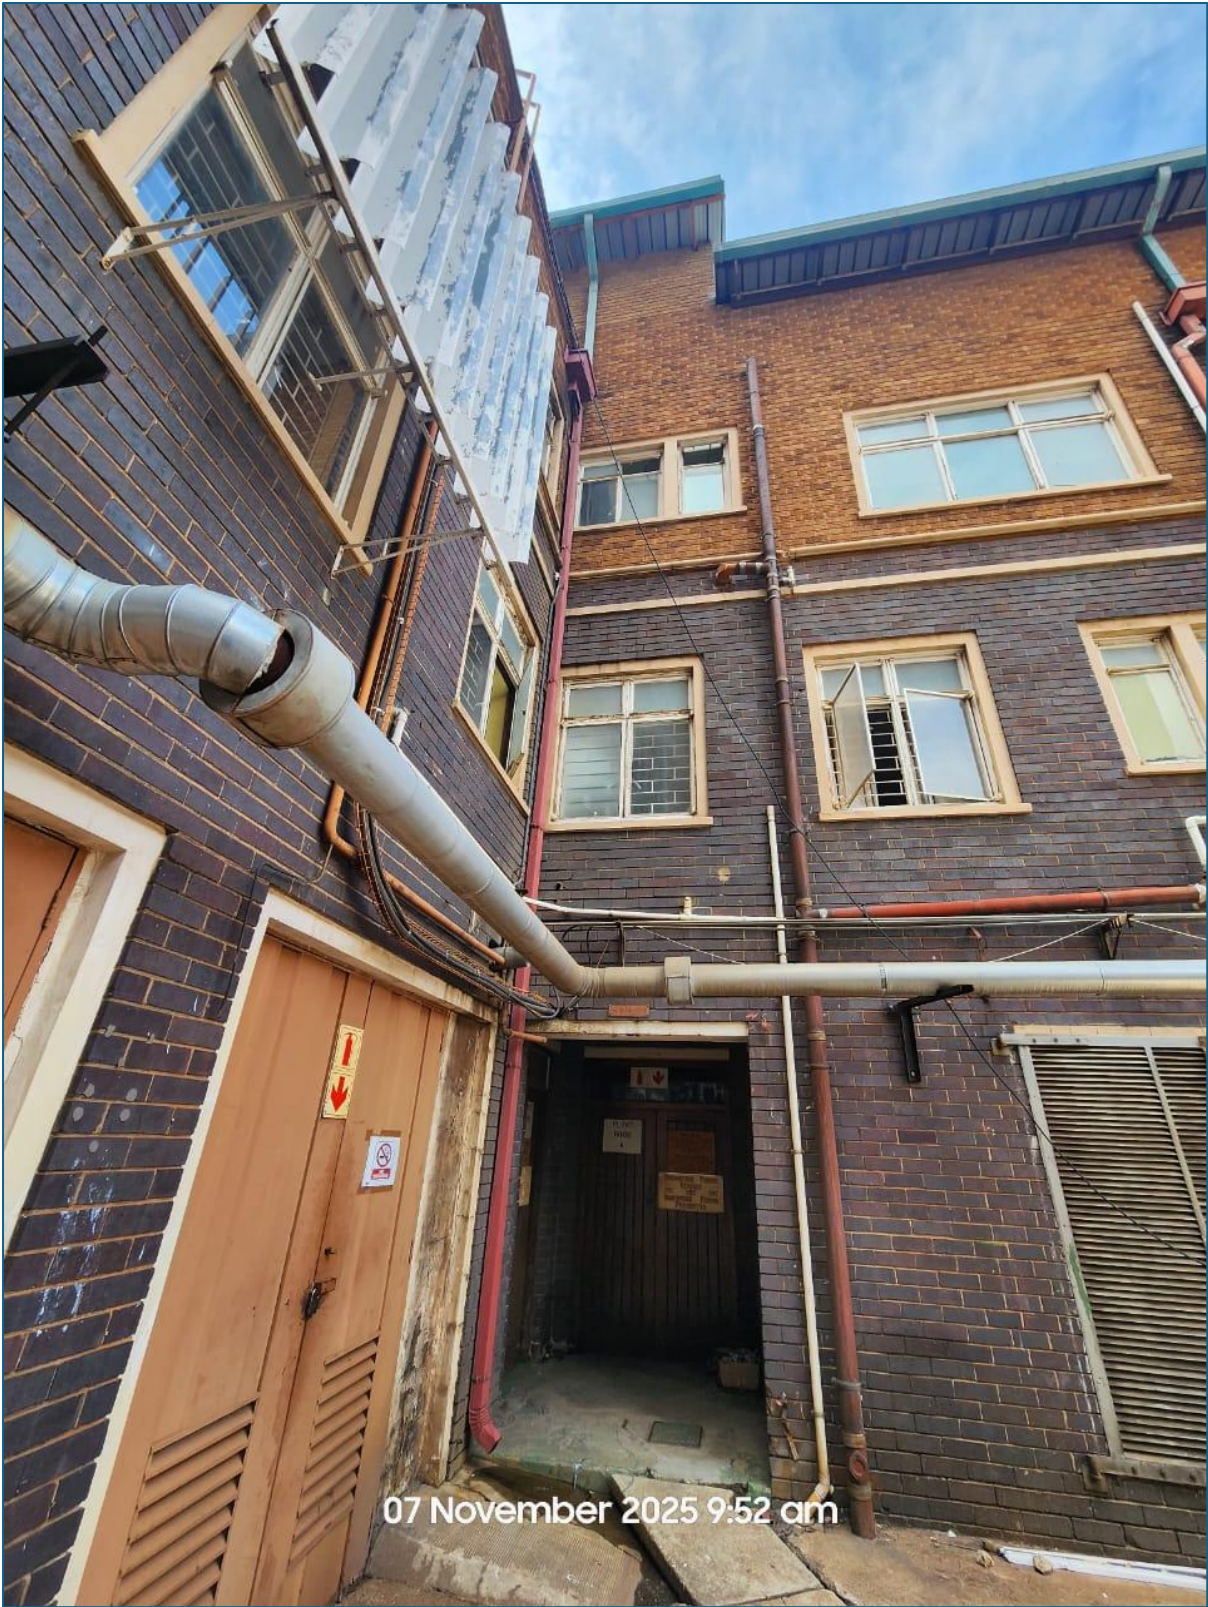
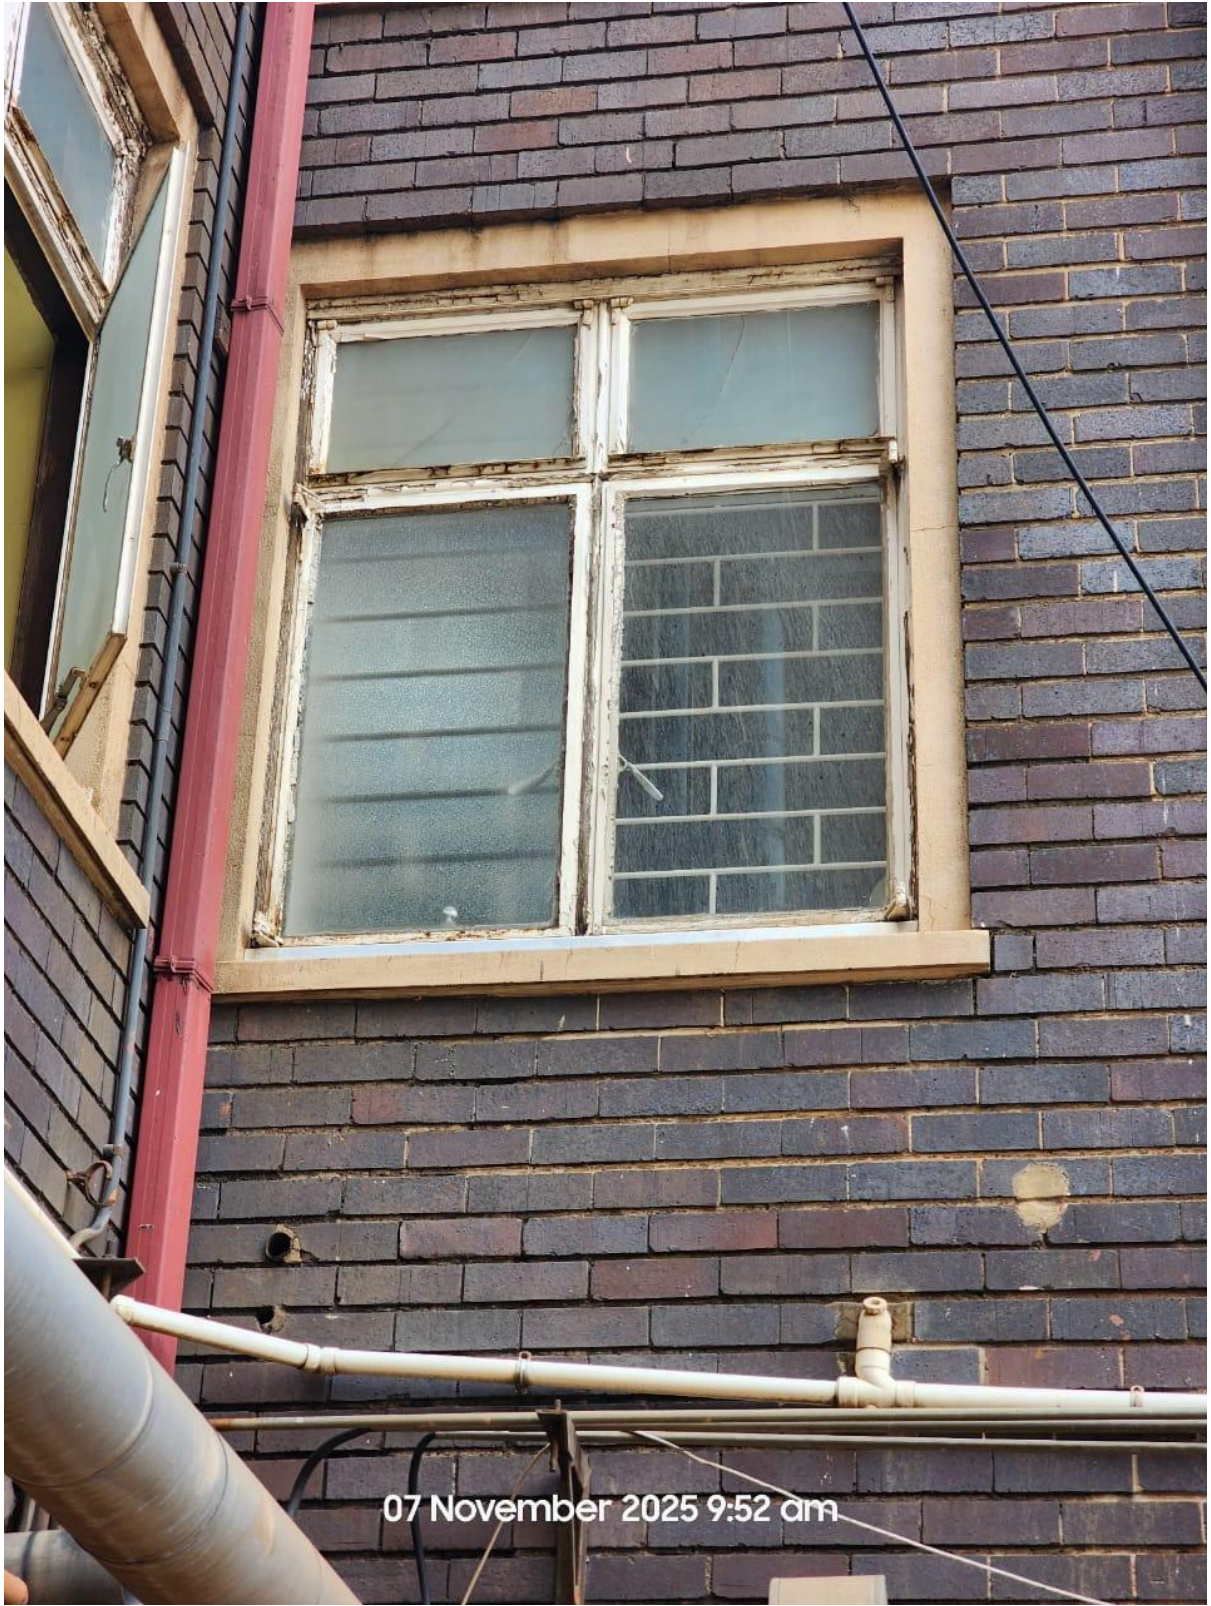
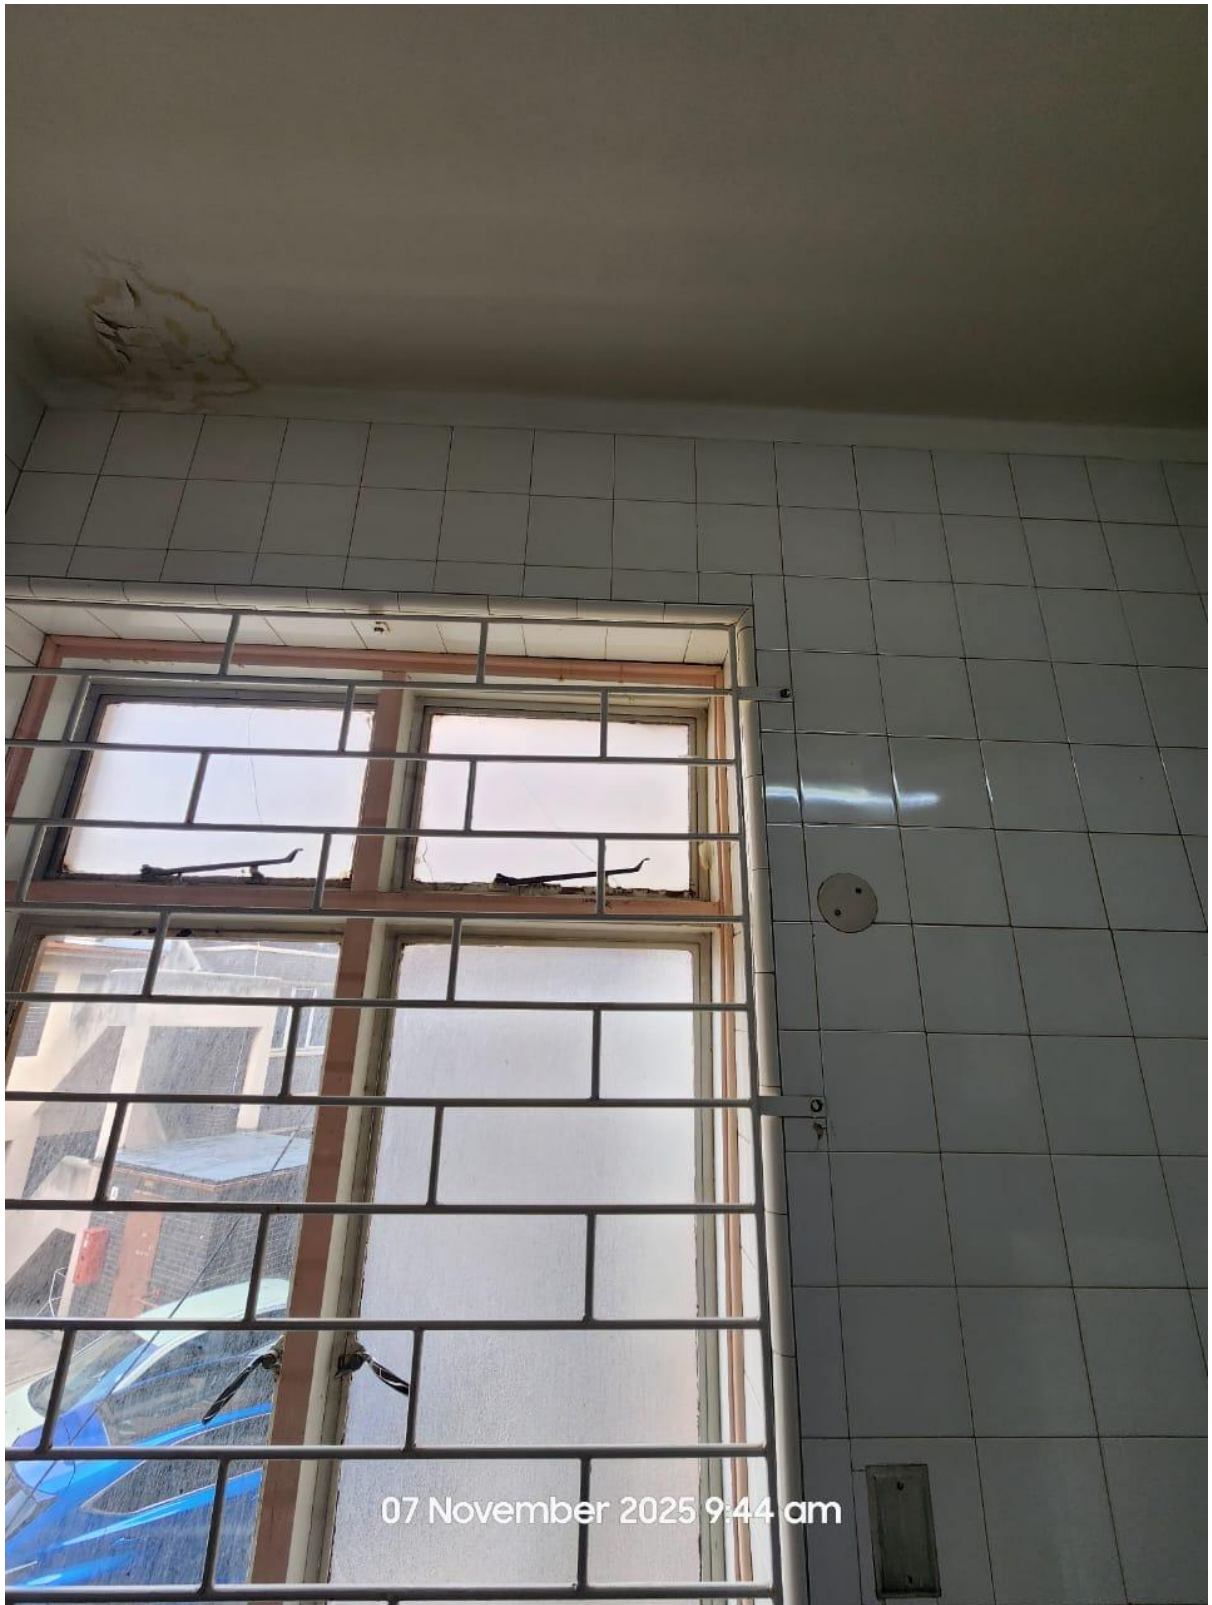
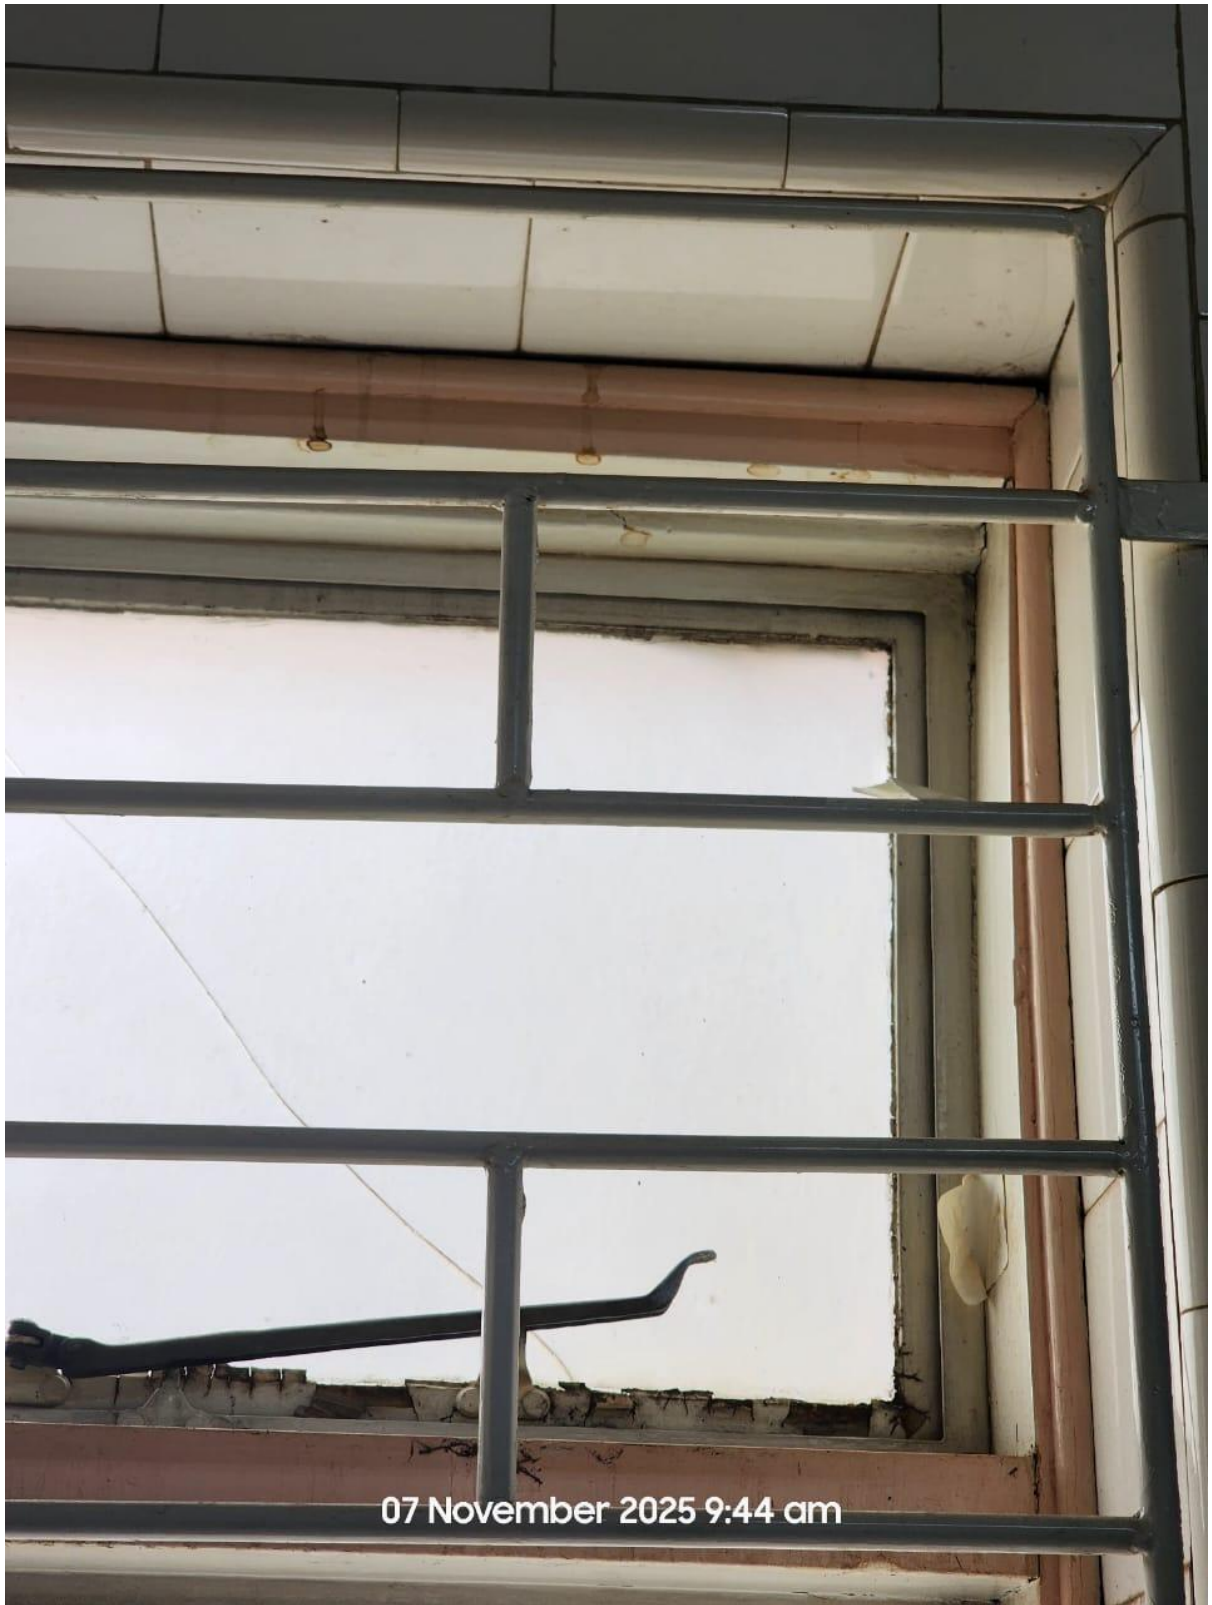
### Incident 3: X-ray Department

This leak is localized and specifically linked to the condition of the exterior window seals, similar to the secondary issue in Incident 2.

<b>Detail</b>	<b>Description</b>
<b>Area Affected</b>	X-ray Department
<b>Location</b>	2nd Floor (Note: The main roof is located on the 4th floor).
<b>Cause of Leak</b>	Rainwater is <b>leaking directly via the window</b> , suggesting failure of the window seals, frame, or surrounding exterior wall sealant. This could also be a result of the blocked gutter on that section.
<b>Proposed Solution</b>	Repair and reseal the window and surrounding frame to stop rain ingress. Check and clean downpipe
<b>Visual Reference</b>	(See attached picture 3: X-ray Window Leak)
